Lettre-Service

No. 1727-25-05

EQUIPMENT AND FURNISHINGS: Sling Work

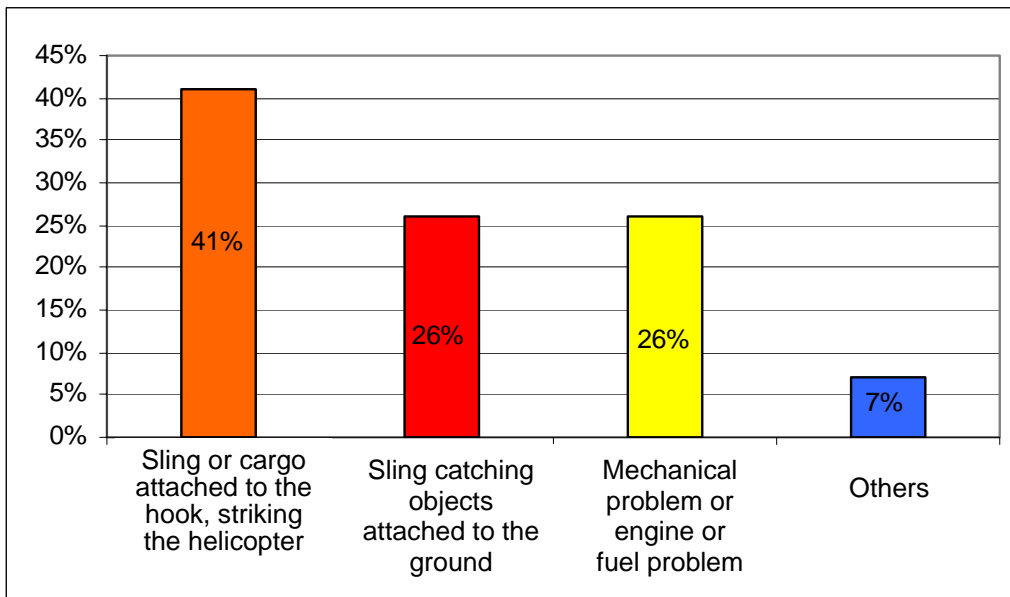
Types of accidents:

2) The causes broken down into 4 categories:

In most of the cases (41%), the sling contacts the tail rotor, which may cause the TGB and parts of the fin to be damaged. The two main reasons are either an abrupt dive maneuver or bursting of the bag which behaves like a parachute when empty. In both cases, the cable and its cargo are subject to airstream loads which prevail over the weight of the cable and cargo. Consequently, the sling or load follows the airstream into the tail rotor area.

The second category includes cases in which the sling becomes entangled with objects on the ground (26%). Most of these cases could have been avoided if there had been a person on the ground to warn the pilot, who cannot see the hook clearly due to the length of the cable. This category also includes cases of slings becoming entangled in aerial lines.

The third category mainly includes LAMA helicopters with several cases of excessive use of collective pitch which, in hot weather or at altitude, causes the engine to surge and can then lead to its destruction (single-shaft engine). In cold weather and at low altitude, repeated torque exceedance can cause damage to the drive train. One LAMA helicopter was involved in an accident due to lack of fuel.

The fourth category includes a dynamite explosion which occurred during a sling operation, and a case of suspected transient control jamming. This event is still under investigation.

Ballast slings, especially those that are less than 10 m long. The effect is obvious in stabilized flight. During descents at airspeeds above V_y , it is possible for the sling to move upward, even with ballast, at load factors less than .5g. This phenomenon can be avoided by conducting descents at airspeeds below V_y .

Failure of a bag can prove to be dangerous given the significant aerodynamic drag to which the empty bag is exposed. Even with no load factor, the sling and bag can move upward toward the tail rotor. You must use very solid bags which are in a good condition, reinforced with solid straps, if necessary. Consideration may be given to utilizing nets rather than bags when the load will allow this alternative.

Attempts to take off with the sling caught on the ground can be avoided if a person, in radio-contact with the pilot, monitors the operation from the ground. This is vital when the cargo hook is not clearly visible either directly or in the mirror. In addition, it is recommended to avoid aggressive take-offs, and to start with a vertical climb before transition to level flight. Thus, the pilot should become aware of a snag because of the restricted climbing capability.
