Support / Program

Marignane, 29/02/2016

This Letter is dedicated to the Ecureuil family (AS350/AS355/H125 and EC130/H130). It brings to your attention more information related to recent protective measures introduced by Emergency Alert Service Bulletins / Alert Service Bulletins, a status concerning some corrective solutions, some details about latest improvements carried out on the Product itself, and finally presents a synthesis of all actions carried out to reduce Costs of Operation and Maintenance for your fleet, even if some information were already provided in the previous Information Letter No. EC 014-2015 (February 2015) & No. EC015-2015 (July 2015), focused on H130 product.

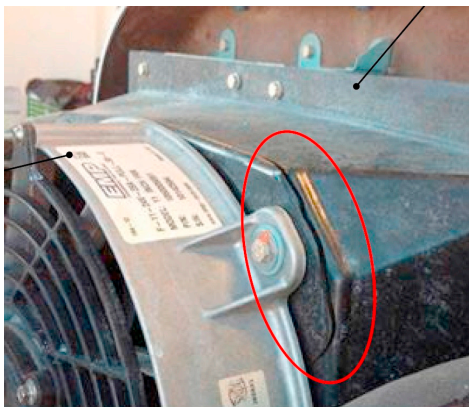
Photo 1

Several cracks were reported over the past months on the fan hopper mount (cf Photo 1).

In October 2014, the Emergency ALERT SERVICE BULLETIN No. EC130-05A020 Rev0 was released, requiring, as protective measure, a periodic visual check (during the P-inspection) of the hopper for crack detection at the attachments of the MGB oil fan to the hopper.

The Revision 1 of this EASB which was distributed in October 2015, provided a corrective solution to replace these checks: installation of 4 stainless steel rods to maintain the hopper mount. This corrective solution known as Mod 07-4547, is defined in Service Bulletin No. EC130-79-001 which has been released simultaneously (Photo 2).

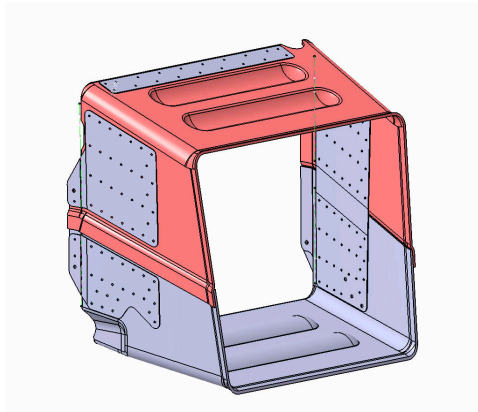
Photo 3

Several cases of cracks have been reported on the air intake on the H130 (this part is made of polycarbonate). The rupture of the part has not been classified as Unsafe. A first solution has been provided to give the possibility to reinforce the current parts (preventive and/or curative solution): this reinforcement consists in adding doublers made of aluminium material (cf Photos 3 & 4). It corresponds to Mod 07-4557, and the retrofit is proposed, Free Of Charge, under Service Bulletin No. EC130-21-013 (released on February 1st, 2016). An improved solution made of carbon material will be proposed before End 2016, on newly produced helicopters and in retrofit (on Customer request) .

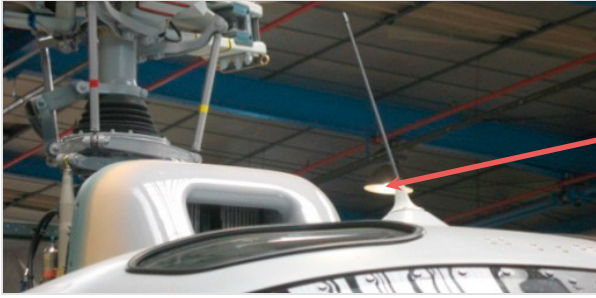
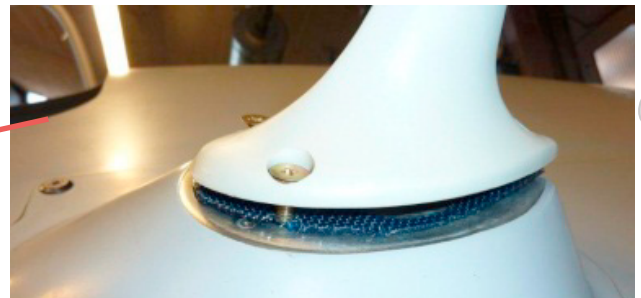
- VHF antenna tightness on the cabin roof (Mod. 07-4715) which is now ensured thanks to the implementation of a seal in between the VHF antenna and its support (cf Photos 5 & 6).

Retrofit of this solution is described in Service Bulletins No AS350-23.00.06 & AS550-23.00.02 which have been released on September 10th, 2015.

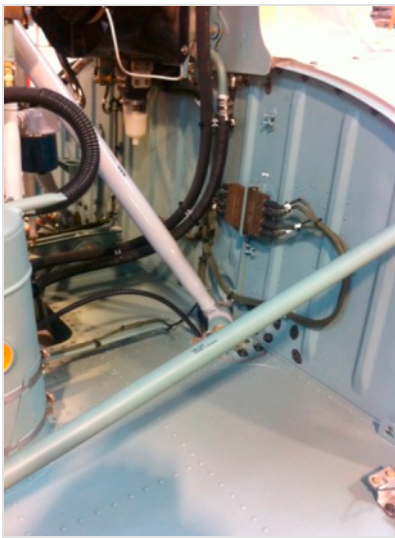
Photo 7 - pre Mod 07-4741

- Cabin air inlet scoop vs 7° bulkhead (Mod. 07-4741): tightness has been improved thanks to addition of a water trap + optimized scoops in the air inlet circuit, as it is already done on H130 / EC130 B4 (cf Photos 7 & 8). The retrofit is described in Service Bulletin No AS350-21.00.19 which has just been released on Feb 22nd.
