Support / Program

Marignane, 29/02/2016

This Letter is dedicated to the Ecureuil family (AS350/AS355/H125 and EC130/H130). It brings to your attention more information related to recent protective measures introduced by Emergency Alert Service Bulletins / Alert Service Bulletins, a status concerning some corrective solutions, some details about latest improvements carried out on the Product itself, and finally presents a synthesis of all actions carried out to reduce Costs of Operation and Maintenance for your fleet, even if some information were already provided in the previous Information Letter No. EC 014-2015 (February 2015) & No. EC015-2015 (July 2015), focused on H130 product.

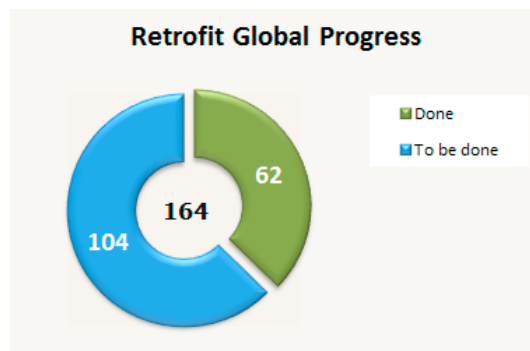
Chart 1 - Current retrofit status

Implementation of these rods, which are provided Free Of Charge, is currently on going (Chart 1) : the deadline fixed by respective Authorities (EASA as well as FAA) is November 22nd, 2016.
